FIRE EFFECTS ON HIGH EFFICIENCY COMPACT FLUORESCENT LIGHTING

Richard J. Meier, CFEI, CFII, CVFI
October, 2012

**International Symposium on Fire Investigation
Science and Technology**
5th International Fire Investigation Conference
University of Maryland,
Hyattsville, Maryland USA

Richard J. Meier, CFEI, CFII, CVFI
Staff Fire and Explosion Analyst
John A. Kennedy and Associates
Fire and Explosion Analysis Experts, USA

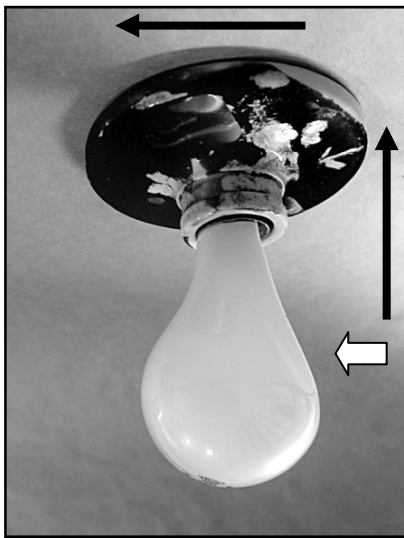
Damage only occurred to the incandescent lights located on the ceiling panel in or directly adjacent to the fire plume. (*Positions C1 and C2.*) No discernible damage occurred to the lights located on the side walls of the chamber, or at the rearmost ceiling fixture. As the thermocouples were also located on a side wall of the chamber, it can be surmised that the gases in the plume and ceiling jet was at a higher temperature in the center of the ceiling than at the side walls. This is confirmed by published softening temperatures for glass in the range of 760–870°C (1400–1600°F),⁶ and by later tests with a thermocouple mounted mid-ceiling.

Figure 9.
"Pulled" bulb.
Position C1, in fire plume.

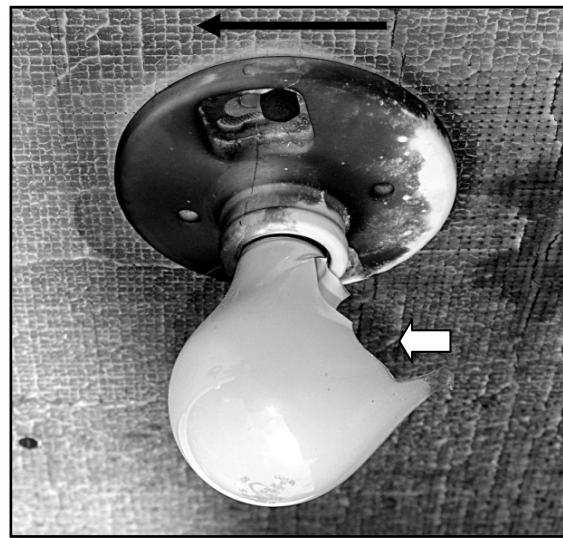
Figure 10.
"Popped" bulb.
Position C2, in ceiling jet.

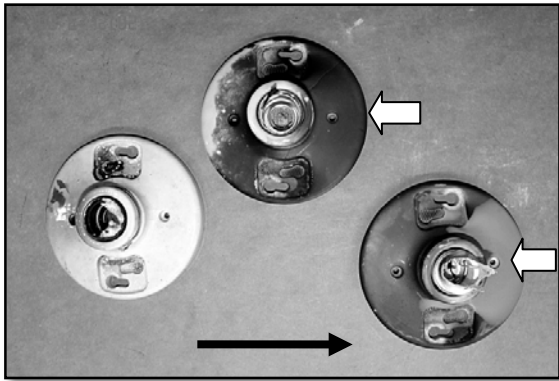
Figure 11.
Ceiling mounted helical CFL's post fire. (Removed from test chamber.) Note increasing residue "shadow".

Another interesting phenomenon seen on several fixtures was a “shadow” on the side of the fixture away from the ceiling jet. The shadow was in the form of a residue and is probably a result of the pyrolysing polycarbonate material being deposited on the fixture. The residue was a tan-gray color, and was easily removed by touching. In general, the greater the distance from the fire plume, the more pronounced the shadow.

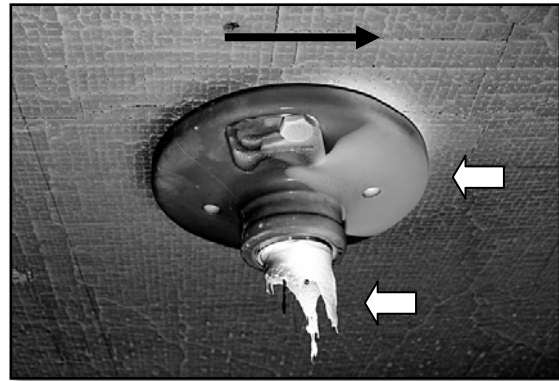
Although little of the helical CFL's was left in the porcelain outlets used in the test, remnants remained in some of the fixtures which could aid in determining the direction of the ceiling jet. Due to uneven heating, the cooler side of the light would typically leave a "tail" hanging down indicating it took longer to soften and had the opportunity to stretch. Depending on the fixtures proximity to the fire plume the tail could burn away or remain intact after the fire.

Figure 12.
Ceiling mounted helical CFL.
"Tail" and residue "shadow" are present.

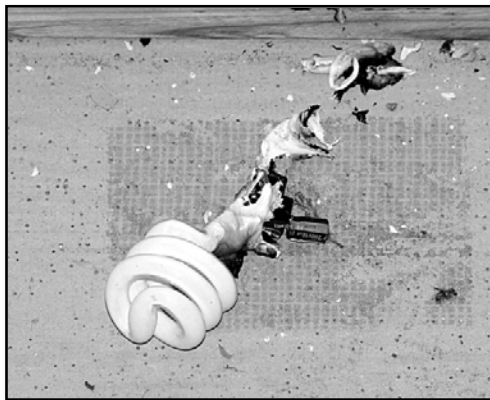
The helical compact fluorescent lights were tested under conditions similar to those used for the incandescent light studies. Unlike the incandescent lights, all of the helical CFL's regardless of position, were damaged during this study. The thermoplastic polycarbonate material of the housing melted and burned, compromising the structural integrity of the light. Typically, very little of the helical lights remained in the porcelain fixture. Also typical, much of the helical CFL's (i.e. the helical tube and ballast) could be found on the floor of the test compartment almost intact, save the damage incurred from the impact with the floor.

Figure 13.
Remains of helical CFL on floor.
Glass tube and electronic components are mostly intact.

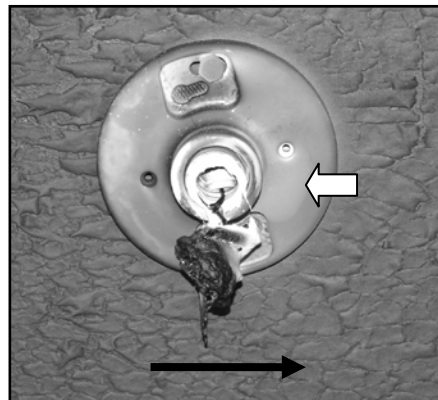
Figure 14a.
Wall mounted helical CFL, position L1.
There is a visible residue "shadow".

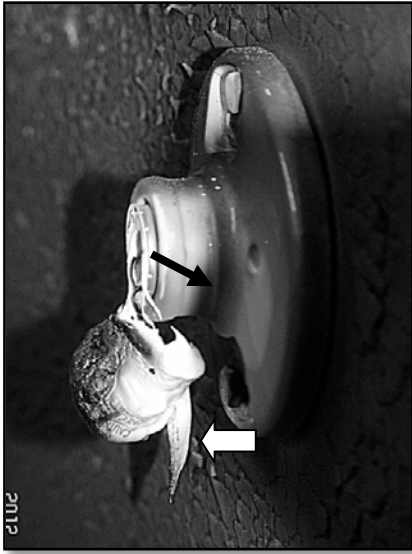
Figure 14b.

Same wall mounted helical CFL post fire.
 Note un-charred side of housing away from ceiling jet.

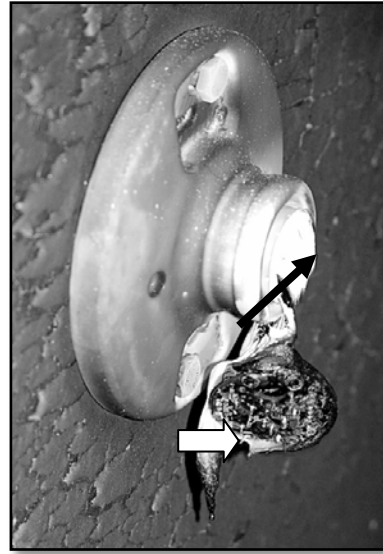
Figure 14c.

Same wall mounted helical CFL post fire.
 Note charred circuit board towards ceiling jet.

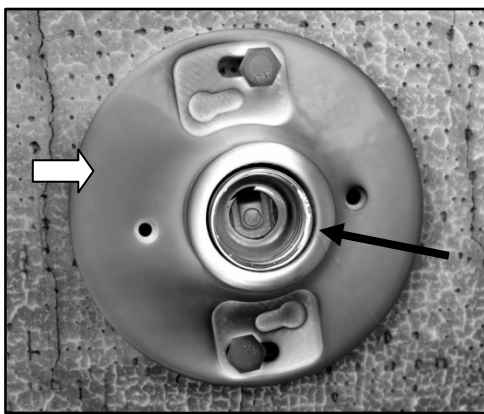
Figure 15a.

It was later discovered that the shadow was more permanent than originally thought. During the second round of testing the porcelain fixtures were being wiped clean between tests. It was found that below the tan-gray dust a dark residue stain had attached itself to the fixtures and was not easily removed (*Fig. 15*). This effect was consistent for both the helical and Type A CFL’s tested. It is most likely that if the fire was of a higher temperature and/or a longer duration that the residue would also burn away.

Fixture showing shadow after fire.

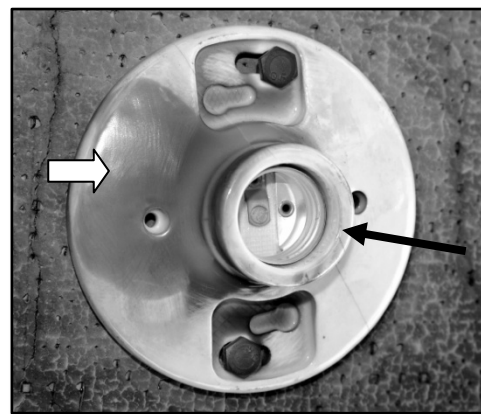
Figure 15b.

Same fixture after wiping with a cloth.
 Note stain matches shadow in previous photo.

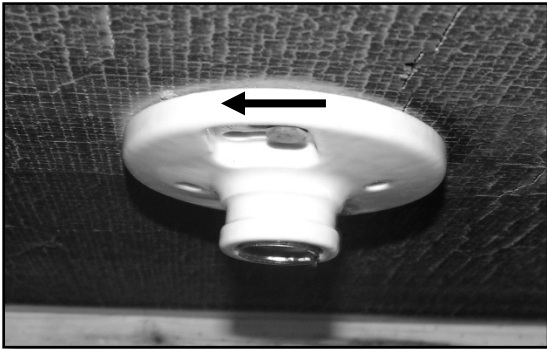
The Type A lights displayed a wider range of damage than the helical CFL's. This may be due to the higher mass of the light and its ability to absorb more heat. On one extreme, absolutely nothing was left of a ceiling mounted Type A CFL except the stainless steel cap screwed into the porcelain fixture (*Fig. 16*). The softening of plastic combined with the weight of the entire construction pulled the light completely free of the cap (*Fig. 17, positions C1 and C2*). The remains of the light lay on the floor, mostly intact, with some melting and charring present (*Fig. 18*). At the other extreme a ceiling mounted Type A CFL remained fairly intact, and had distinct damage on the side facing the ceiling jet (*Fig. 19, position C3*). Damage to the Type A CFL's on the side walls was similar to that found on helical CFL's (*Fig. 20 and 21, positions L1 and R1*).

Figure 16.
Ceiling mounted Type A CFL, position C1.
Only the cap remains in the fixture.

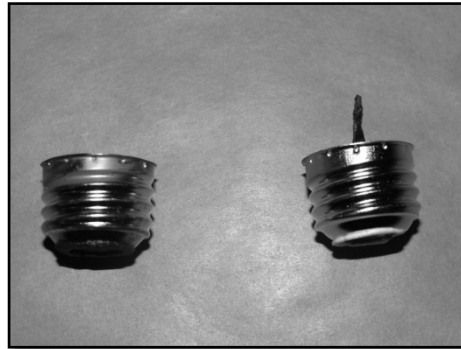
Figure 17.
Caps from ceiling mounted Type A CFL's.
From ceiling fixtures in positions C1 and C2.

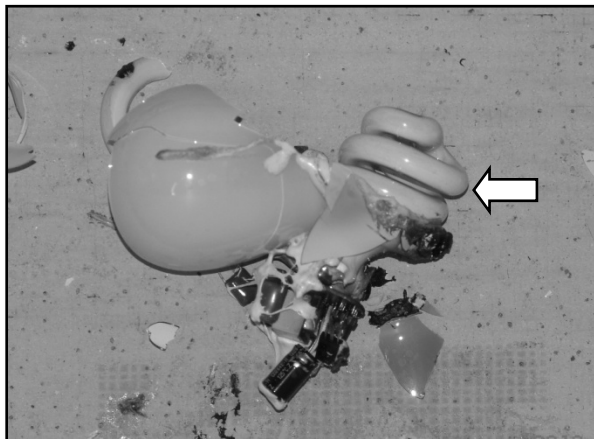
Figure 18.
Remains of Type A CFL on floor.
Many components survived, including an intact glass tube.

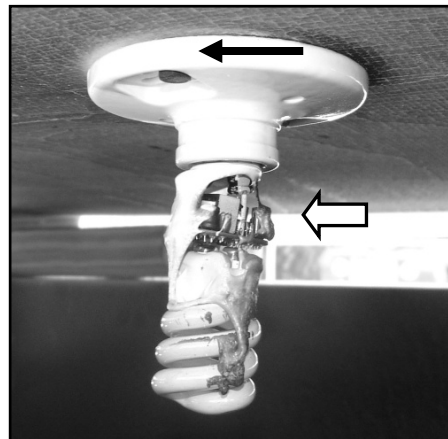
Figure 19.
Ceiling mounted Type A CFL position C3.
Melting is heavier on side facing the ceiling jet.

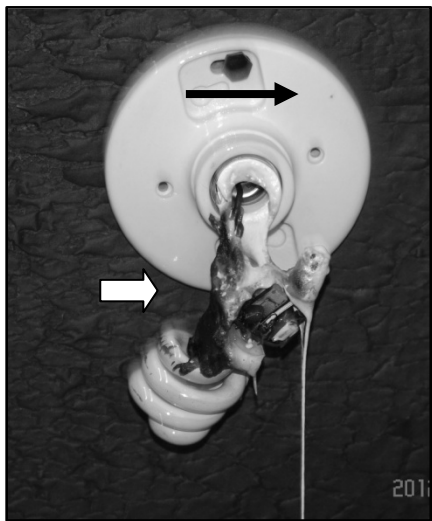
Figure 20.
Wall mounted Type A CFL position L1.
Charring is heavier on side facing the ceiling jet.

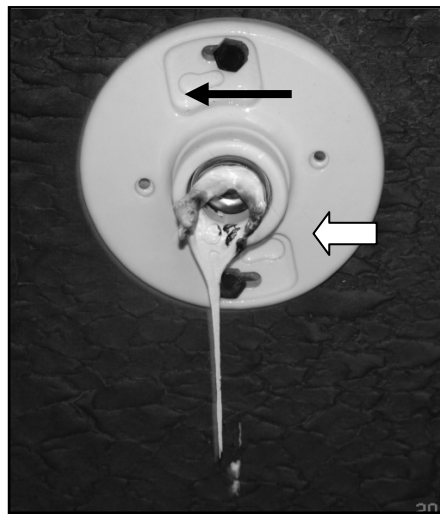
Figure 21.
Wall mounted Type A CFL position R1.
Although the light is almost completely missing,
charring still occurred on the side facing the ceiling jet
still occurred.
