FULL-SCALE ROOM BURN PATTERNS STUDY

ABSTRACT

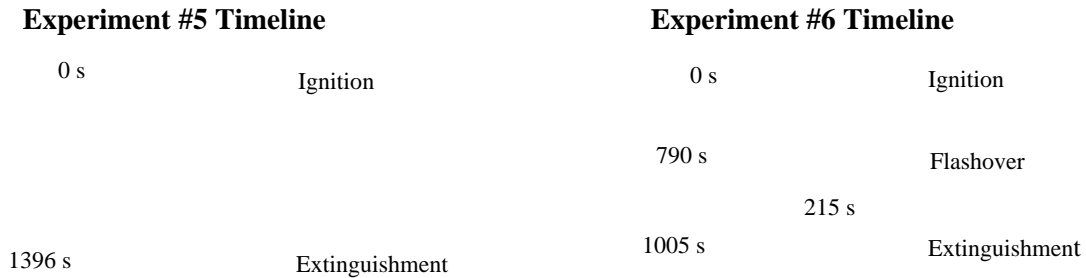
Figure 11 – Comparison of Timelines Experiment Set “C”

room involvement did not occur. This was evident from the radiometer readings (figure 14), as well as the post-fire inspection of the furnishings (Figures 34, 38, 42 and 46). In cell #2 (experiment #6), the technical indicators for flashover of 600°C (1112°F) in the upper layer and radiant flux of 20kW/m² at the floor were achieved at 790s (Figure 15). The duration of the post-flashover/fully involved stage of the fire for experiment #6 was 215s. Figure 11 illustrates a timeline for each experiment.

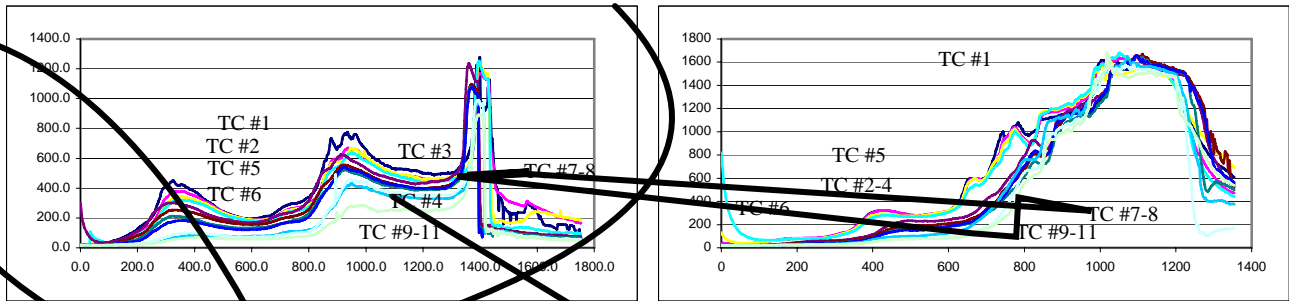
Figures 12 & 13 – Experiment Set “C” Thermocouple Data: (left)-Cell #1 (exp. 5); (right)-Cell #2 (exp. 6)

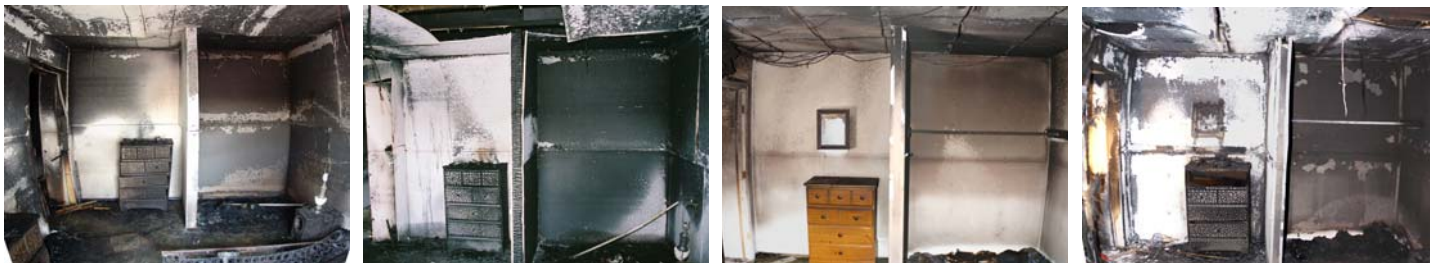
Along the north wall, a similar area of clean burn located on the west side above the chest was witnessed for the three experiments that progressed to full-room involvement (Figures 32, 33 and 35). Also, similar lines of demarcation are witnessed for all four experiments (Figures 32-35).

Figure 32-35 – North Wall (left to right) Exp. Set “A”: Cell #1, Cell #2; Exp. Set “C”: Cell #1, Cell #2

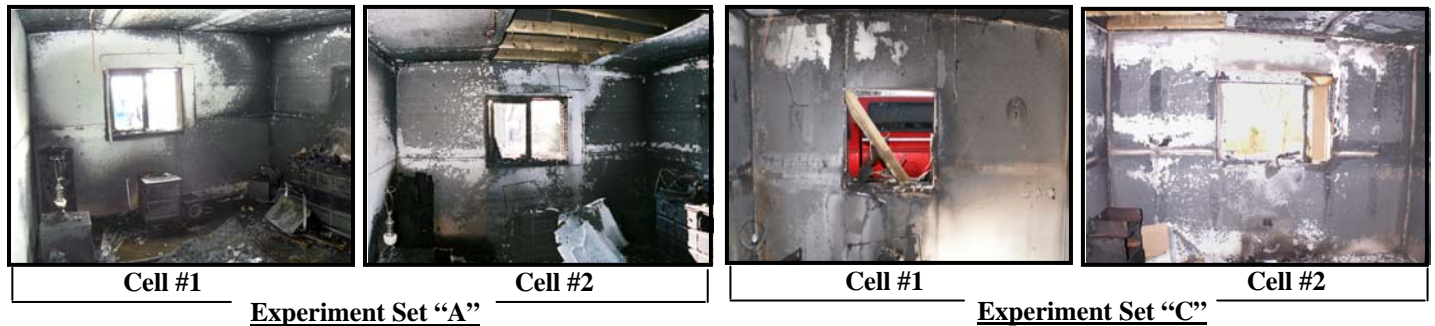
The plume pattern on the east wall also extended onto the south wall with an area of greater damage (clean burn) for all four experiments witnessed near the ceiling of each wall and the window. Additionally, a “U-Shaped” pattern was witnessed along the south wall for all four experiments that corresponded with the truncated cone of the plume originating from the bed (Figures 40-43).

Figure 40-43 – South Wall (left to right) Exp. Set “A”: Cell #1, Cell #2; Exp. Set “C”: Cell #1, Cell #2
