A FIRE ANALYSIS TOOL REVISITED

ACOUSTIC SOOT AGGLOMERATION IN RESIDENTIAL SMOKE ALARMS

Interflam 2004
10th International Engineering
Conference
Edinburgh, Scotland
July 4-7, 2004

**John A. Kennedy & Associates, Inc.
Fire and Explosion Analysis Experts
857 Tallevast Road
Sarasota, Florida 34243**

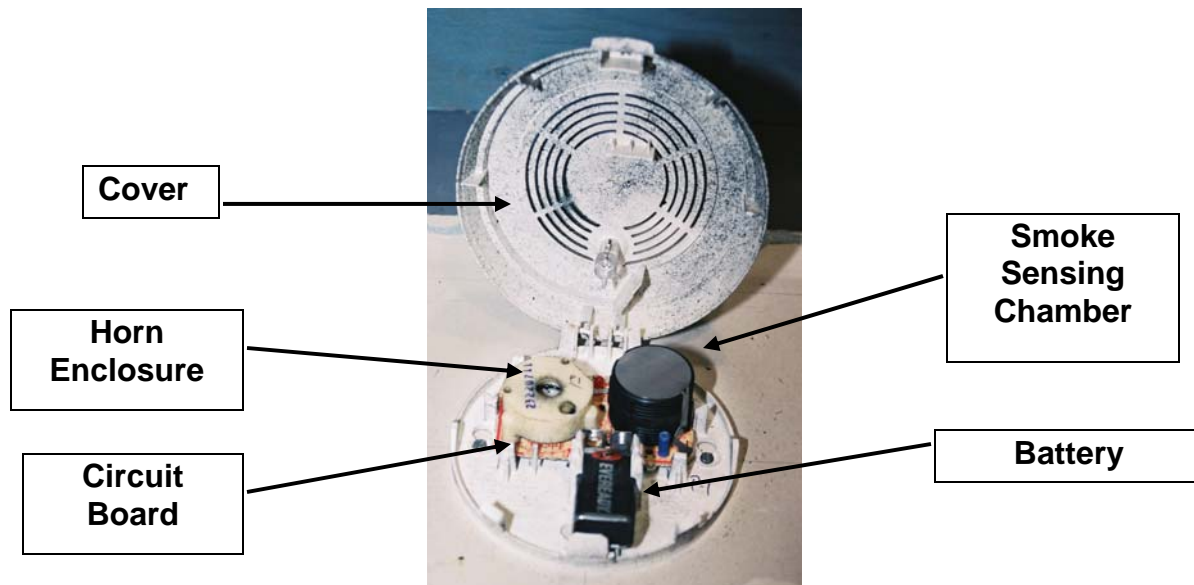
Figure 1 – Typical smoke alarm components

Most modern single station residential smoke alarms are designed and operate similarly. The basic components are a power source, smoke-sensing chamber, printed circuit board, horn, and an outer container or cover (See Figure 1).

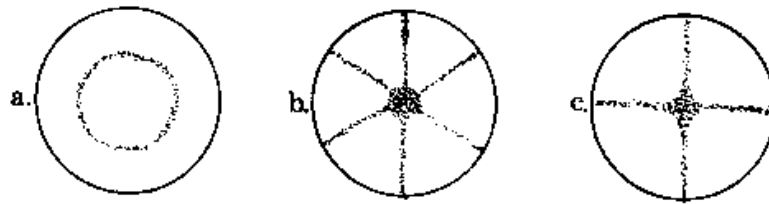
Figure 2 - Examples of Circumferential (circular) and radial Chladni figures

On circular plates, similar in shape to the smoke alarm horn disk, Chladni Figures can be displayed as circumferential circles centered at the center of the flat disk (see a. in Figure 2a), radial arms radiating outward from the center of the disk or combinations (see Figure 2b and c)

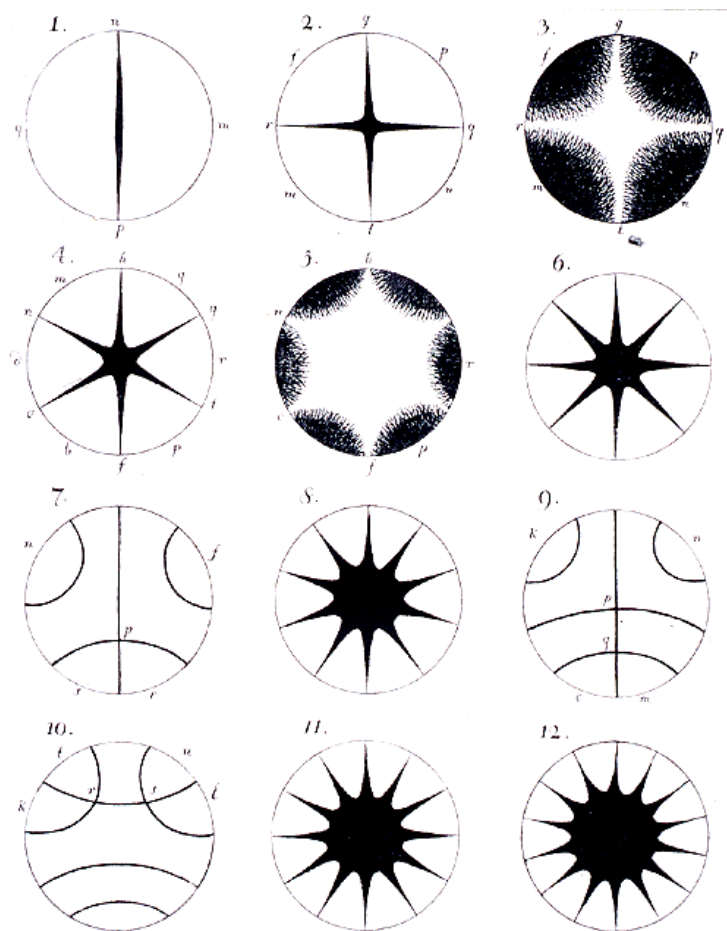
Figure 3 – Additional Chladni Figures
(from Chladni’s original text).^{11,12}

and variations of both including certain “starburst” type shapes (see Figure 3, nos. 4, 6, 8, 11 and 12).

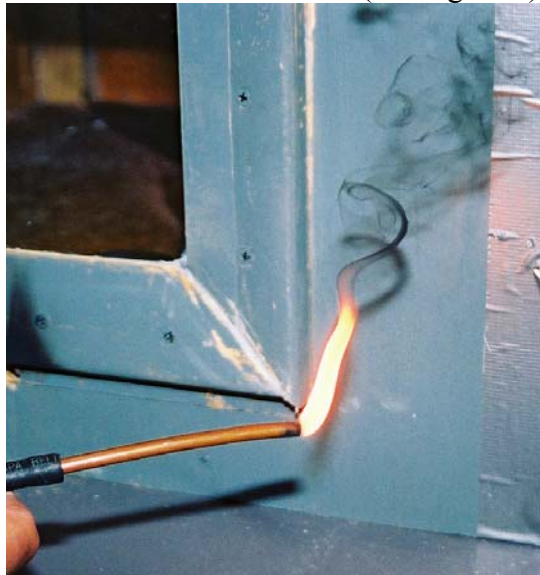
Figure 4 – Smoke Source, 2” laminar MAPP Gas flame

The smoke source was an ~2” laminar gas flame of MAPP Gas (C_3H_4) (mixture of 56.0% Propane and 44.0% methylacetylene-propadiene) from a ¼” diameter copper tube burner. The ~2” MAPP Gas laminar flame from a ¼” diameter copper tube burner produces an extremely sooty black smoke which is primary carbon soot in composition. The smoke source is inserted into a hole in the lower center of the chamber front wall beneath the viewing window and extends into the chamber at floor level a distance of 6” (see Figure 4).

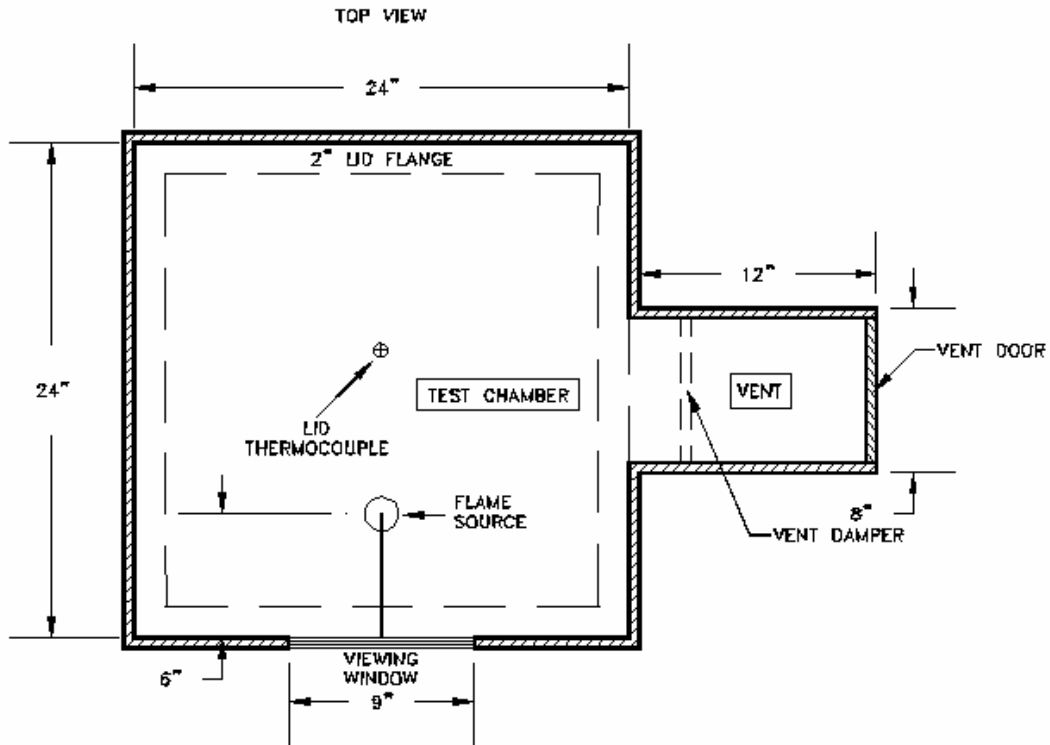
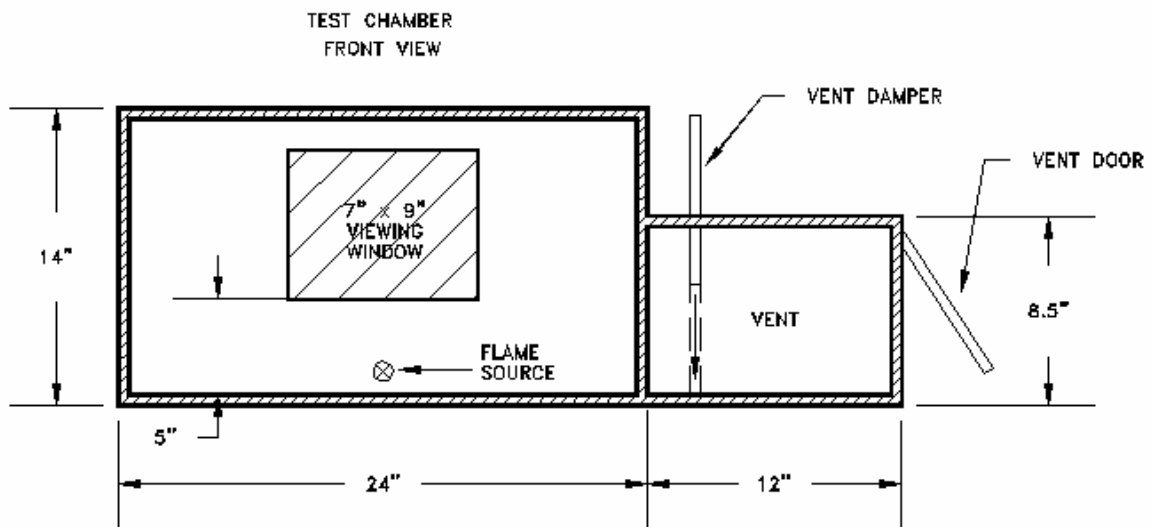
A specially constructed smoke chamber was used in all testing. It measured 24”L x 24”W x 14”H, producing an interior volume of 2.8 cu. ft. There was a 9”W x 7”H glass viewing window placed 5” above the chamber floor in the center of the front wall. The 24” x 24” lid of the chamber was constructed of ½” gypsum wallboard and fit (smoke-tight) into the top of the chamber on nominal 2” horizontal flanges. In the center of the right wall of the smoke chamber was an 8”W x 8.5”H manually operated dampered smoke vent. This vent remained closed during testing.

A type “K” thermocouple was attached to the inside surface of the chamber ceiling on the lateral centerline ~2” forward of the tested smoke alarm (see Figures 5 and 6).

Figure 5 - Top View Drawing of Smoke Test Chamber

Figure 6 - Front View Drawing of Smoke Test Chamber

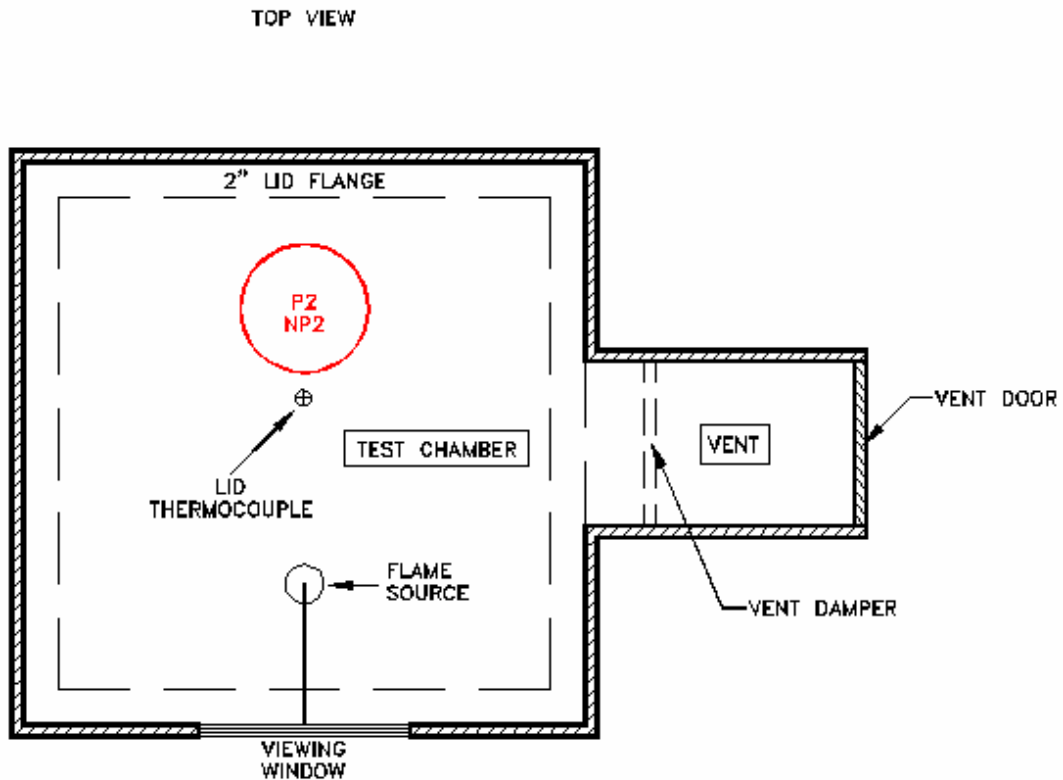
Figure 7 – Top View of Smoke Test Chamber displaying Smoke Alarm Placement

A test smoke alarm was powered, either with a prescribed internal 9V battery or if a hard wired designed unit, with external standard house line 120V AC, and attached in place on the interior ceiling (lid) of the test chamber. The monitoring thermocouple was attached through the top of the chamber lid and the lid is screwed in place onto the nominal 2” flanges. (See Figure 7).

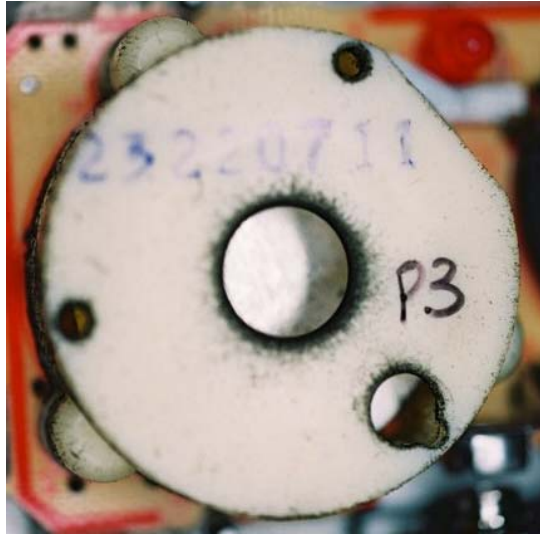
Figure 8 – Acoustic Soot Agglomeration around central and circumferential sound holes of a powered horn disk enclosure.

The presence of soot agglomerations is a strong indicator that a particular smoke alarm activated properly in a fire (see Figure 8).

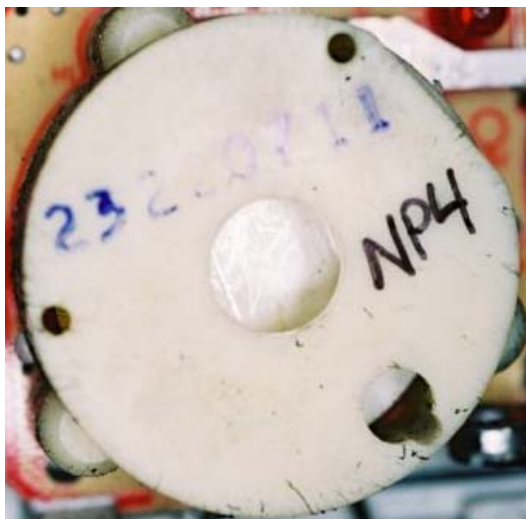
Figure 9 – Lack of Acoustic Soot Agglomeration on the horn enclosure of a non-powered smoke alarm

Absence of soot agglomeration products on a fire exposed smoke alarm is evidence that the alarm did not sound, providing that the atmosphere to which the smoke alarm was exposed was sufficiently sooty (see Figure 9).

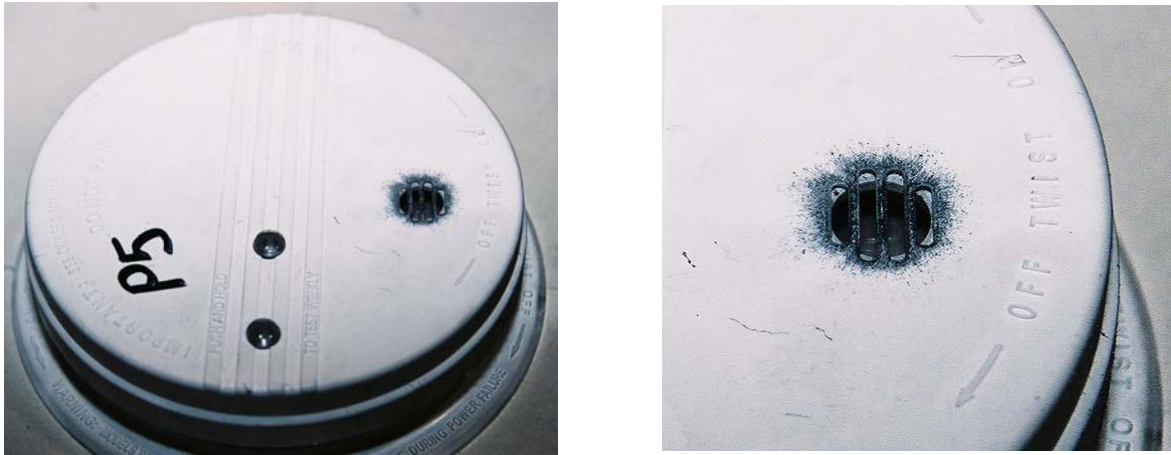
Figures 10 a. and b. – Acoustic Soot Agglomeration around the sound exit grillwork of a Kidde Smoke Alarm

External agglomeration will appear in the cover grillwork of properly operating smoke alarms, particularly in the areas of horn chamber sound outlets (see Figures 10a and 10b and Figure 11).

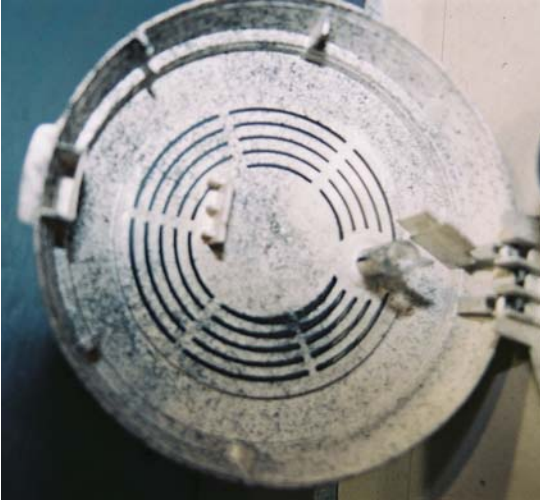
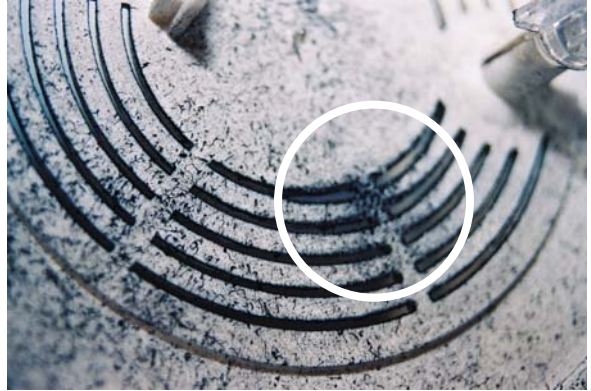
Figures 12a. and b. - Acoustic Soot Agglomeration on the interior surface of the smoke alarm case directly over the horn compartment central sound exit opening

Internal Agglomeration will appear on various internal parts of a properly operating smoke alarm, particularly the sound exit openings of horn enclosures, but also frequently on such other parts as electrical components, circuit boards, and the inside surfaces of the cover grillwork close to the horn disks or horn enclosures (see Figures 12a. and 12b.).

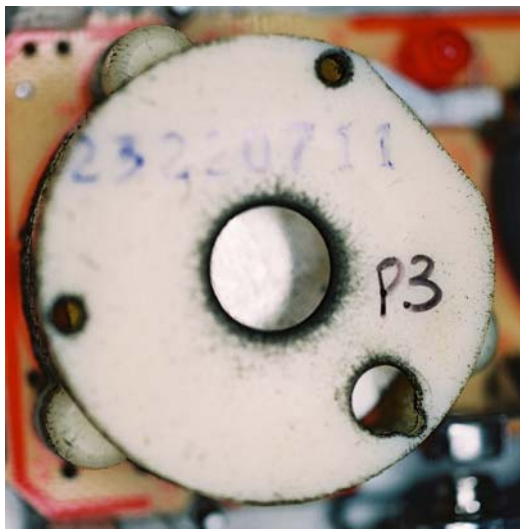
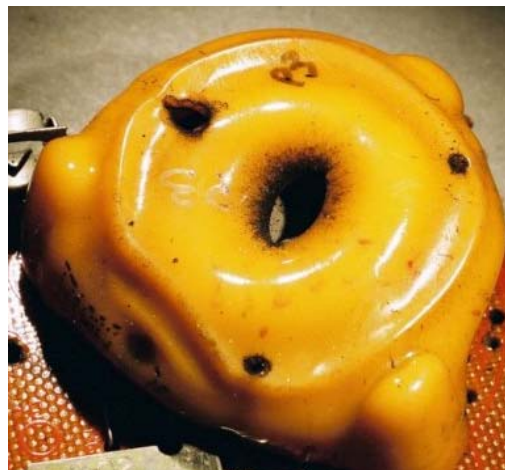
Figures 13 a. and b. – Patterns Persistence
Soot agglomeration on a horn enclosure central sound exit opening before (left) and After (right) heating to 433° F. (223° C) for thirty minutes

Through heating to temperatures exceeding the approximate temperature at which smoke alarm falldown occurs, 283° F. (139° C), soot deposit patterns persistence occurs as long as the subject smoke alarm is not completely destroyed by subsequent burning.

In a second single specific bench test, a previously smoke tested smoke alarm, (P3) bearing acoustic soot agglomeration was subjected to 30 minutes of heating to a temperature of 433° F. (223 C) in a lab furnace. After air cooling the resultant softened and re-solidified plastic of the outer cover and the horn enclosure were examined to see if the deposited Acoustic Soot Agglomerations persisted.

Patterns Persistence – To test patterns persistence, a previously smoke tested alarm, (P3) bearing acoustic soot agglomeration was subjected to 30 minutes of heating in a lab furnace to a temperature of 433° F. (223° C). After air-cooling the resultant softened and re-solidified plastic of the outer cover and the horn enclosure were examined to see if the deposited Acoustic Soot Agglomerations persisted. Patterns persistence was evident.
