FULL-SCALE ROOM BURN PATTERNS STUDY

ABSTRACT

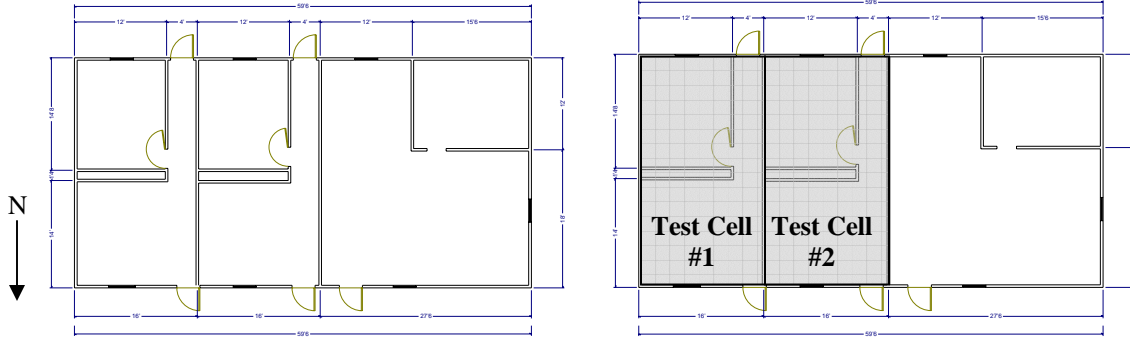
The test facility used for all these recent experiment sets was the Eastern Kentucky University, Fire and Safety Engineering and Technology Program’s test burn building, located on the EKU campus in Richmond, Kentucky. This structure is a specially constructed, single story building with overall dimensions of approximately 18.9 m x 9.75 m (62 feet x 32 feet). It incorporates six interconnected burn rooms and two hallways all with 8” reinforced concrete walls and roof. Individual test cells can be configured into various shapes and sizes by isolating individual spaces with gypsum wallboard partitions (see Figure 1).

Figure 1 (left) layout of EKU test burn building; Figure 2 (right) location of test cells

The test cells for this research project encompassed the east half of the facility configured into two identical 4.88 m by 9.75 m (16' by 32') cells (Figure 2). The cells were constructed of 8" poured, reinforced concrete walls, which were lined with 2x6 joists and gypsum wallboard (See Figure 2). All dimensions are approximated.

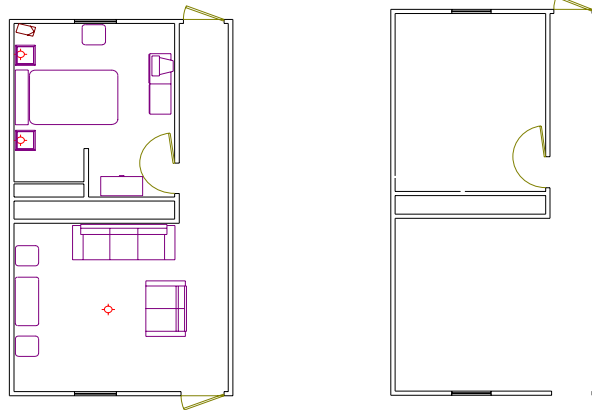
Experiment sets "A" and "C": Experiment sets "A" and "C" (conducted in March 2005 and March 2006) were roughly identical in the layout and types of furniture (Figure 3). The rooms were furnished as typical residential bedrooms and living rooms. The contents of each bedroom included a bed, chest, two lamps, end tables, two nightstands, television (not included in experiment set "C"), clothing and a dresser with an attached mirror. The bedrooms had wall-to-wall carpeting on the floor. The contents of each living room included a couch, loveseat, coffee table, two end tables, and television. The living room as well as the hallway had wall-to-wall carpeting on the floor.

Experiment set "B": Experiment set "B" (conducted in November 2005) was furnished as a residential living room. The living rooms consisted of a couch, loveseat, three end tables, two lamps and a coffee table. The living room as well as the hallway had wall-to-wall carpeting on the floor. The bedroom consisted of a single mattress with bedding material (Figure 4).

**Figure 3 (left) Furniture Layout for Experiment Set "A" & "C";
Figure 4 (right) furniture layout for Experiment Set "B"**

All experiment sets were ignited by the application of a propane torch to a small plastic bag containing a 4"x4" piece of cotton fabric rag doused with about 4 ml gasoline. Experiment sets "A" and "C" were ignited near the head of the bed on the polyurethane bedspread. Experiment set "B" was ignited near the center of the couch at the base of the vertical cushion.

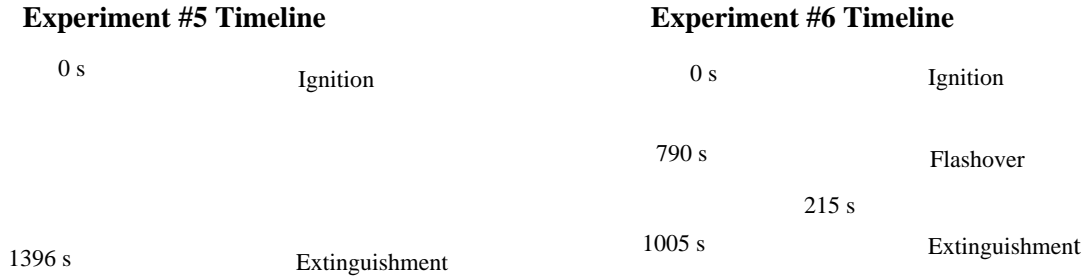
room involvement did not occur. This was evident from the radiometer readings (figure 14), as well as the post-fire inspection of the furnishings (Figures 34, 38, 42 and 46). In cell #2 (experiment #6), the technical indicators for flashover of 600°C (1112°F) in the upper layer and radiant flux of 20kW/m² at the floor were achieved at 790s (Figure 15). The duration of the post-flashover/fully involved stage of the fire for experiment #6 was 215s. Figure 11 illustrates a timeline for each experiment.

Figure 11 – Comparison of Timelines Experiment Set “C”

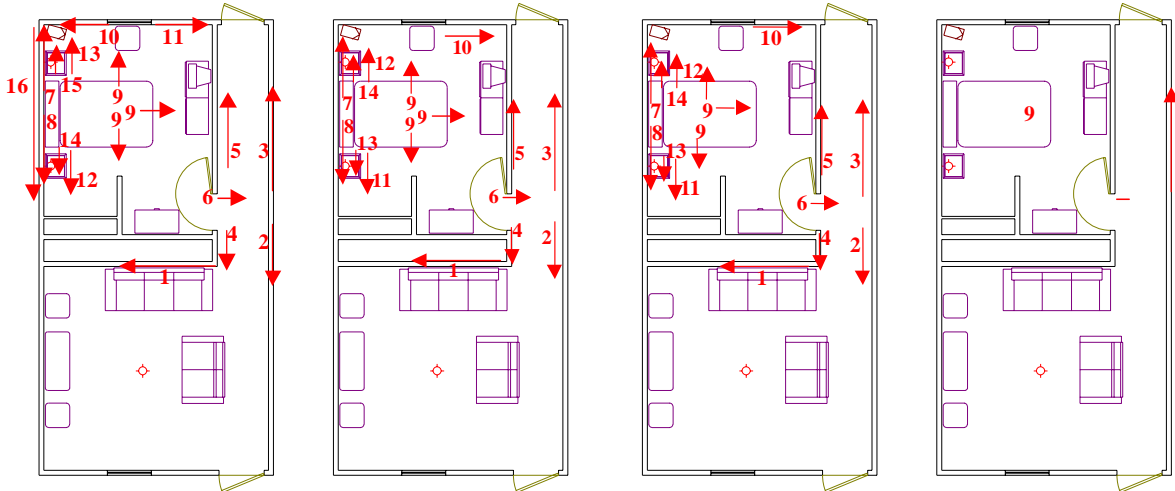
Heat and Flame Vector Analysis: Each experiment was individually analyzed for all identifiable patterns. A heat and flame vector (arrow) was drawn on the respective diagram for each pattern to represent the direction of movement (fire spread). Experiment sets “A” and “C” were identical in furniture layout, and therefore, have been placed side-by-side for comparison purposes of their respective heat and flame vector diagrams (Figures 16-19). Experiment set “B” heat and flame vector diagrams are shown in Figures 20 and 21.

Figures 16-19 – Comparison of Heat and Flame Vector Diagrams
(left to right) Experiment Set “A”: Cell #1; Cell #2; Experiment Set “C”: Cell #1; Cell #2

The Heat and Flame Vector diagrams for experiment sets “A” and “C” (experiments 1, 2, 5 and 6) demonstrate consistency. In fact, the first nine vectors for all four experiments show remarkable resemblance to each other and form the basis for the reliability of utilizing patterns and heat and flame vector diagrams for the accurate identification of an area of origin. Experiment set “B” (experiments 3 and 4) demonstrates even stronger consistency in vector analysis. Every pattern from experiment #3 was reproduced in experiment #4.

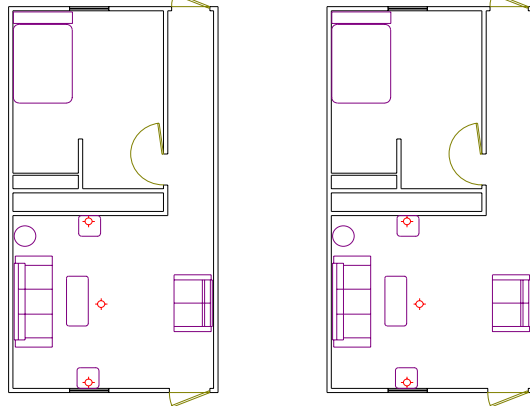
Figures 20 & 21 – Comparison of Heat and Flame Vector Diagrams
(left to right) Experiment Set “B”: Cell #1; Cell #2

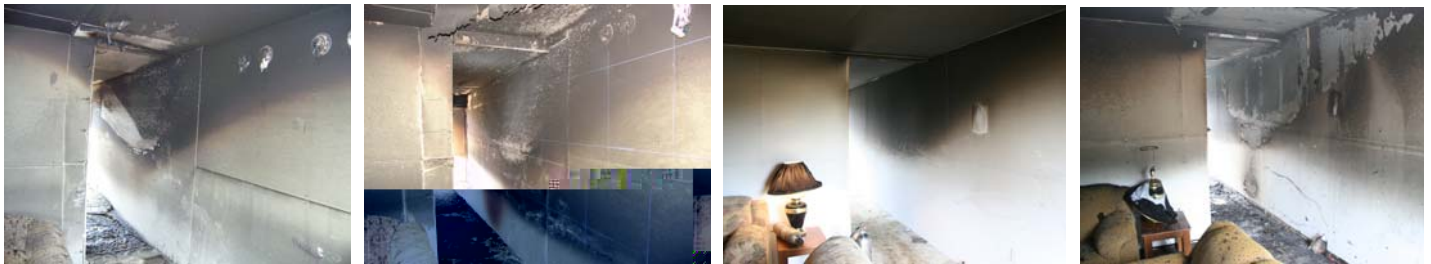
Similar truncated cone patterns (i.e. boundary patterns) were witnessed on the walls in all four experiments. The patterns remaining on the hallway walls demonstrate consistency. All four experiments produced a “U-shaped” pattern opposite the doorway on the hallway wall. The only difference that existed was the pattern in experiments #2 and #6 had a lower vertex than experiments #1 and #5 (Figures 28-31).

Figure 28-31 – Hallway (left to right) Exp. Set “A”: Cell #1, Cell #2; Exp. Set “C”: Cell #1, Cell #2

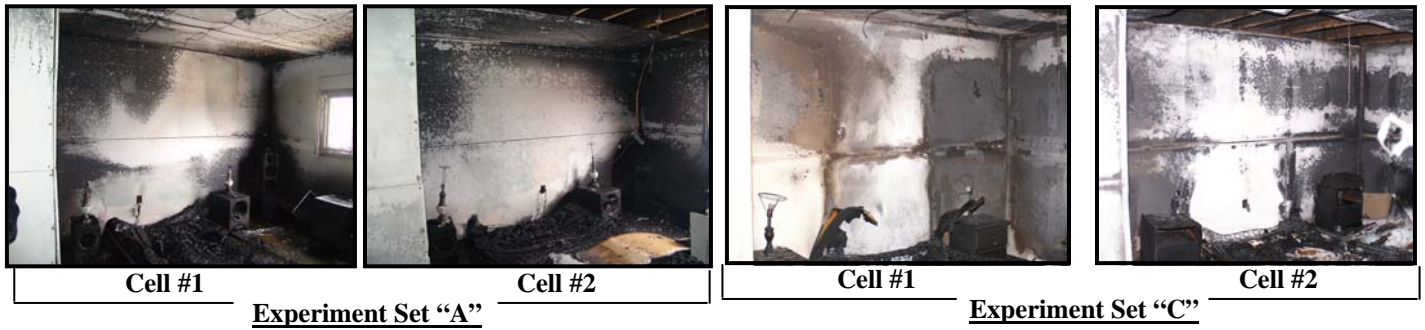
A consistency of the plume pattern on the east wall directly above the bed was witnessed for all four experiments. Additionally, a similar elongation of the plume pattern toward the south wall, where the window was located, was witnessed in all four experiments (Figures 36-39).

Figure 36-39 – East Wall (left to right) Exp. Set “A”: Cell #1, Cell #2; Exp. Set “C”: Cell #1, Cell #2

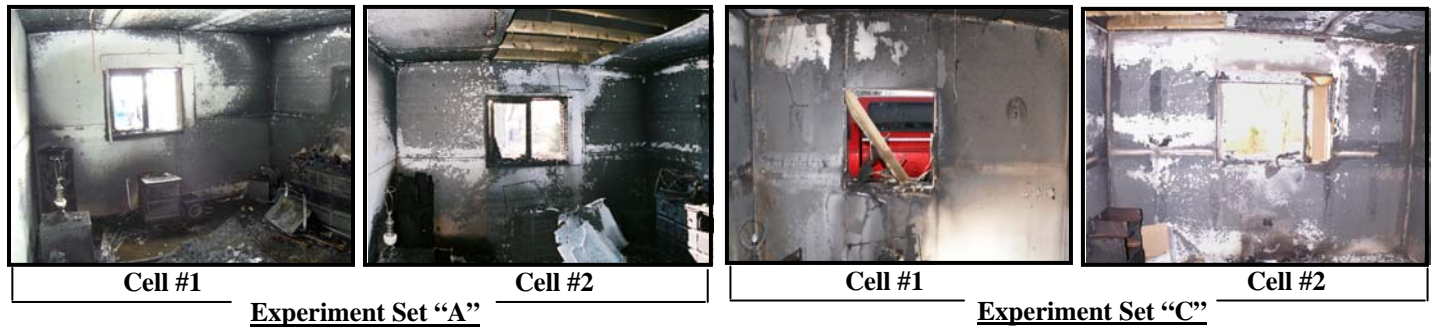
The plume pattern on the east wall also extended onto the south wall with an area of greater damage (clean burn) for all four experiments witnessed near the ceiling of each wall and the window. Additionally, a “U-Shaped” pattern was witnessed along the south wall for all four experiments that corresponded with the truncated cone of the plume originating from the bed (Figures 40-43).

Figure 40-43 – South Wall (left to right) Exp. Set “A”: Cell #1, Cell #2; Exp. Set “C”: Cell #1, Cell #2

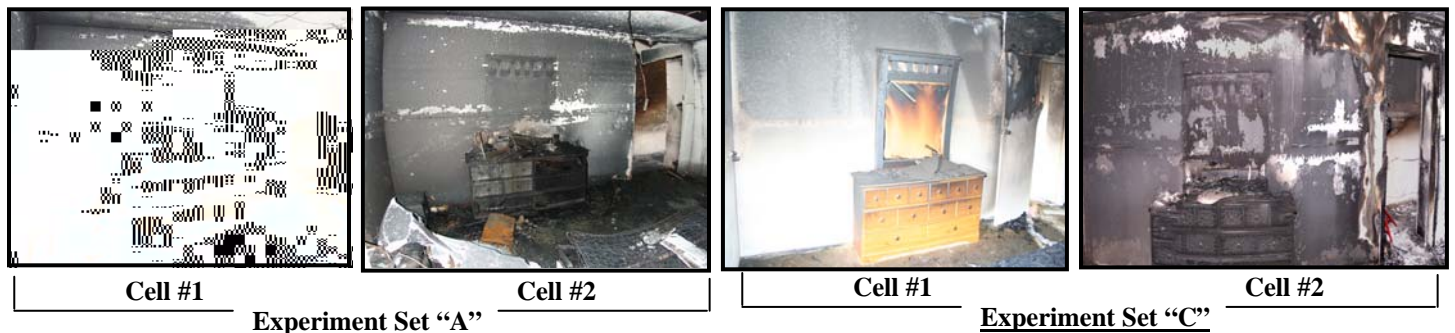
The patterns remaining on the west wall of the bedroom in all four experiments show good consistency (Figures 44-47). For example, protected area patterns remain on the west wall in the pre-fire location of the door and mirror for all four experiments.

Figure 44-47 – West Wall (left to right) Exp. Set “A”: Cell #1, Cell #2; Exp. Set “C”: Cell #1, Cell #2

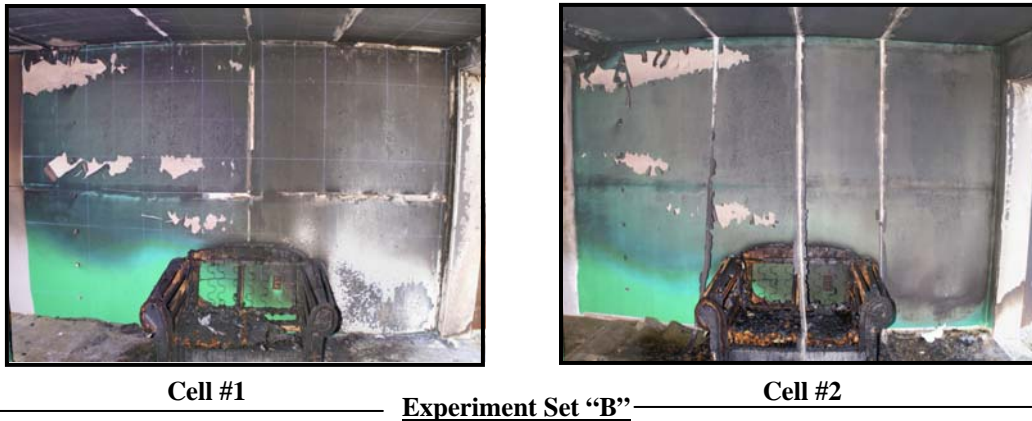
Experiment set “B” (experiments #3 and #4) demonstrated remarkable similarity of the fire patterns. The loss of material patterns for the couch, loveseat, and end tables were almost identical (Figures 48-55). The ventilation patterns near the doorway were similar (Figures 48 and 49). The demarcation lines on the west wall corresponding to the airflow over the loveseat were nearly exact (Figures 48 and 49).

Figure 48-49 – Experiment Set “B”: West Wall - Cell #1 (left); Cell #2 (right)

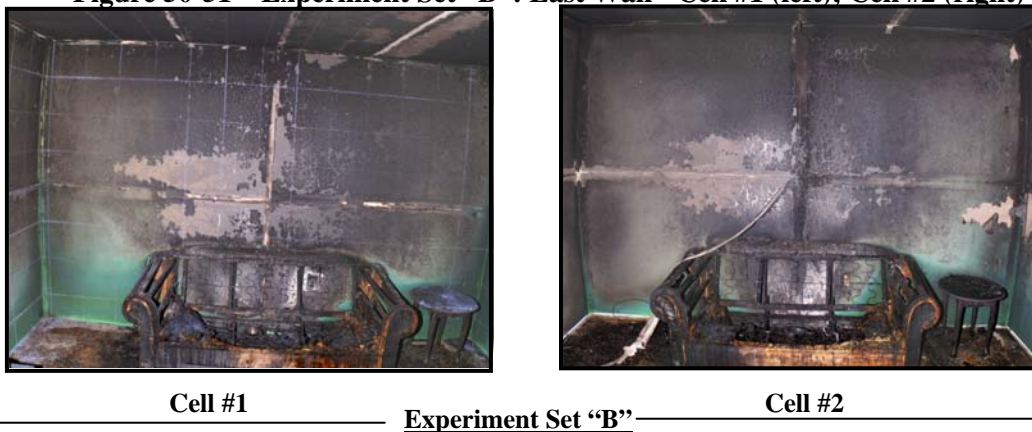
Located on the east wall above the couch, a conical-shaped plume pattern existed in almost exact appearance between the two experiments (Figures 50 and 51). In fact, an almost perfect reproduction of the area of clean burn remained on each wall behind the couch.

Figure 50-51 – Experiment Set “B”: East Wall - Cell #1 (left); Cell #2 (right)

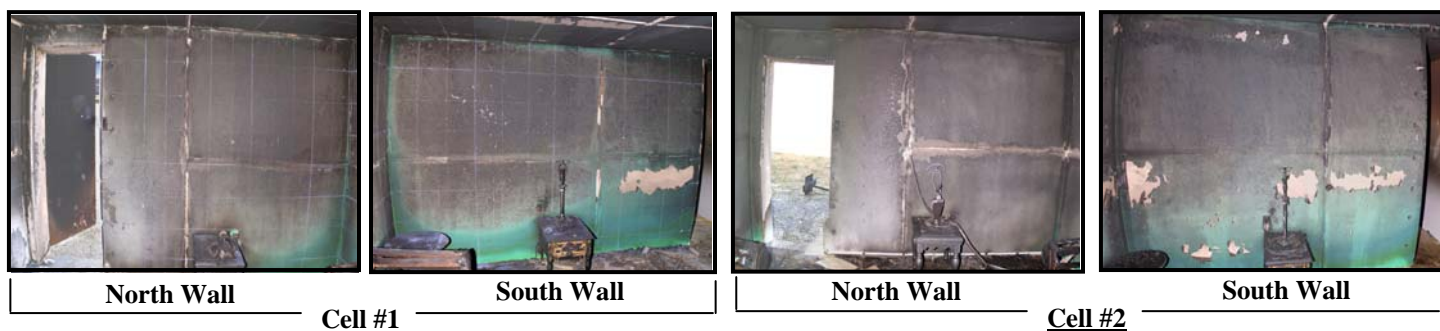
The remaining walls had similar truncated cone patterns, which originated from the plume on the couch (Figures 52-55).

Figure 52-55 – Experiment Set “B”: (left to right) Cell #1; Cell #2
