# Depth of Calcination Measurement In Fire Origin Analysis

Presentation at the  
**Fire and Materials 2003**  
8<sup>th</sup> International Conference and Exhibition  
San Francisco, California  
January 28, 2003

This is a report on a research project into the practical use of measurements of depth of calcination of room-fire exposed gypsum wallboard, under actual fire scene investigation conditions, to discover and illustrate movement and intensity fire patterns for fire origin determination. The work builds on the previously published research of Posey and Posey, 1983; McGraw and Mowrer, 1999; Mowrer, 2000; and Schroeder and Williamson, 2000 and the procedures outlined in NFPA National Fire Codes component document NFPA 921-2001, *Guide for Fire and Explosion Investigations*, sections 4.12 through 4.12.4.

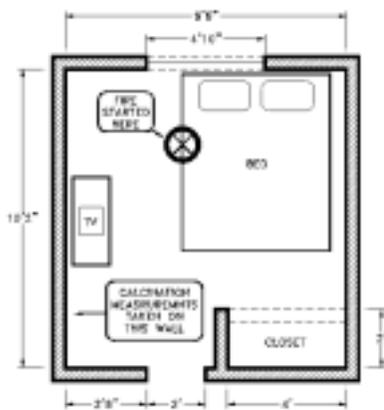
1. Bedroom Test Room

The bedroom test room was 9'6" x 10'2" with an 8' ceiling. There was an open 6'6" x 2' doorway to the exterior at the left side of the front wall, and a small 4' x 2' open closet on the front wall adjacent to the door. The flooring was 12" x 12" vinyl floor tiles. There was a closed 4'10" wide x 3' high double-hung window 43" above the floor in the center of the wall opposite the door and closet. Three standard duplex electrical outlets were installed in the walls, but were not energized.

The bedroom was furnished with a standard 6' x 5' metal bed frame, box spring and foam mattress, made up with cotton sheets, acrylic blanket and pillows. A small chest of drawers with a TV on top was placed on a sidewall opposite the bed. The closet contained clothes hung on wire hangers and a plastic laundry basket filled with clothing on the floor. An un-accelerated fire was ignited by lighting the bottom edge of the bedclothes on the left side of the bed approximately 2.5 feet from the head with an open flame.

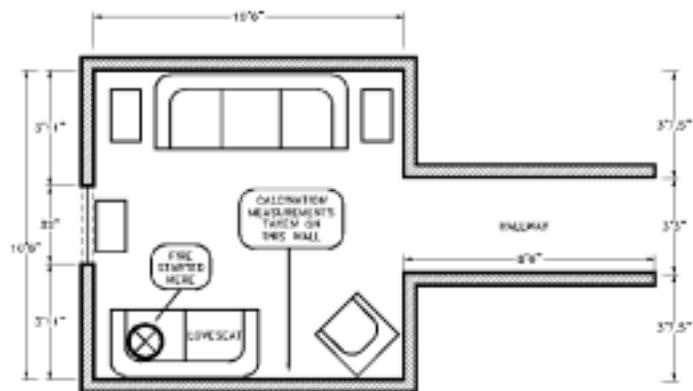
2. Living Room Test Room

The living room was part of a completely separate two-room test facility. It was 10'6" square with an 8' ceiling. There was a closed 32" wide, 50" tall double hung window located in the center of the rear wall, 32" above the floor. In the center of the opposite (front) wall there was the opening of a 3'3' wide, 80" high doorway leading to an 8'6" long hallway that served as the entrance. The front end of the hallway was open to the exterior. There was no door. The floor was carpeted.

The living room was furnished with an upholstered loveseat in the rear left corner along the left wall, a small wooden cabinet under the window, a matching upholstered couch centered on the right wall, flanked by wooden end tables, the front end table held a un-energized typical home coffee maker, and a wooden framed, upholstered cushioned chair was in the front left corner. An un-accelerated fire was set on the seat of the loveseat at the rear, left corner with an open flame applied to newspapers.

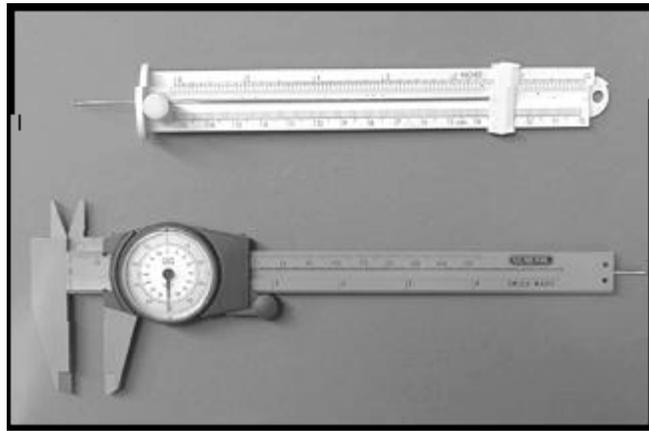
3. Depth Gauge and Dial Caliper<sup>14</sup>

**Depth Gauge** – A probe depth gauge marketed for measuring the depth of sprayed-on thermal insulation. It has a circular cross-section steel probe of 0.127 cm (0.05”) diameter with a slightly chiseled tip. It records depth measurements in either 1/16” or 0.1 mm increments.

**Dial Caliper** – A relatively inexpensive, plastic body, dial caliper with a circular cross-section steel probe of 0.178 cm (0.07”) diameter and a flat circular cross-section tip. It records measurements in 0.01” or 1/64” increments. It should be noted that more expensive dial calipers tend to be equipped with larger square or rectangular cross-section probes that are less suitable for insertion into the calcined GWP.

Comparisons of the individual tests data records indicate that the dial caliper instrument was easier to read, especially by those not familiar with the two instruments, tended to produce fewer “questionable” notations of depth measurements and thereby, within the parameters of the research project, produced somewhat more reliable information than the depth gauge. In addition, because of the versatility of the various measuring modes allowed by the dial caliper, it is more useful overall to the fire investigator for other types of measurements that might be needed at a fire scene.

However, the depth gauge did have two useful features that the dial caliper did not. A locking screw for the probe when used by the participant tended to prevent an inadvertent change in the measurement when the probe was pulled out of the GWB and then read. The depth gauge also had a 1.13” diameter circular platform just above its probe that helped the participant be sure of making depth measurements more nearly perpendicular to the wall surface.

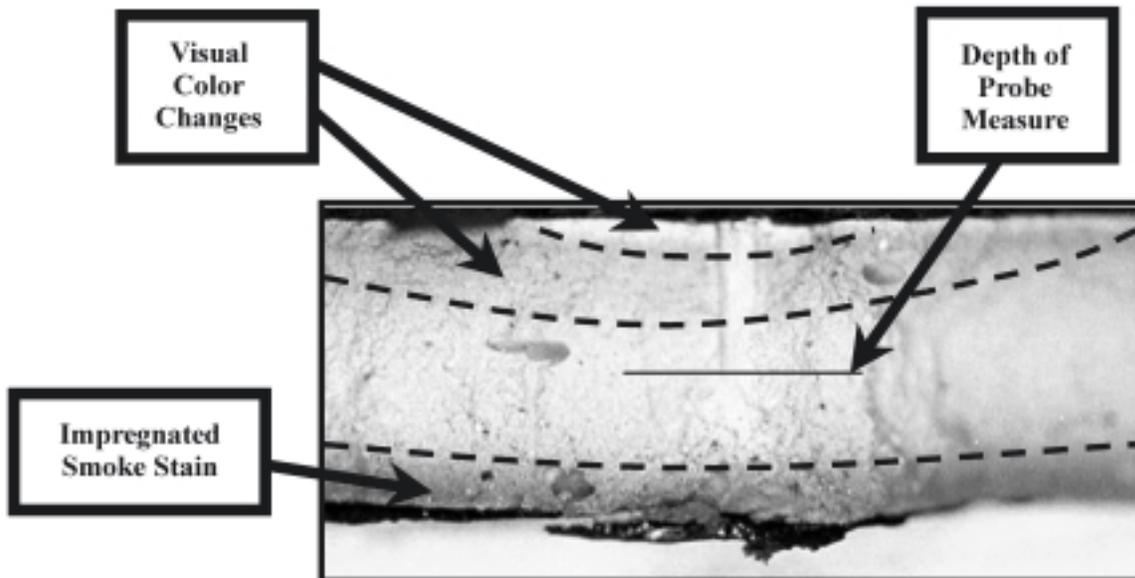
4. Cross-Section of 1/2" GWB Sample from Bench Tests

To supplement the field measurements portion of the research some laboratory tests were conducted into the change in density of GWB when heated. Several 4" square samples of regular 1/2" GWB were prepared. The samples were conditioned for several days at approximately 72°F. and 50% relative humidity. Each sample was weighed and then subjected to the same standard flame source for varying times. The standard flame source was a Fisher burner adjusted to produce a 12", premixed propane flame. Each sample was suspended on a ring stand 4" above the burner. After air-cooling the samples were weighed again, probe tested for calcination depth and then cross-sectioned and the visual color differences were measured. One sample was weighed and subjected to a 500C (932°F.) temperature in a muffle furnace for two hours to produce total calcination. After air-cooling the fully calcined sample was weighed again.

This aspect was studied during the laboratory bench tests into the mass loss and density change rates. Observed visual color changes in the test samples were of consistently less depth than the probe measurements. However the relative differences between measured depths per total flux were consistent for both types of measurements. Therefore, though the quantitative differences did exist, the qualitative analyses were unaffected.

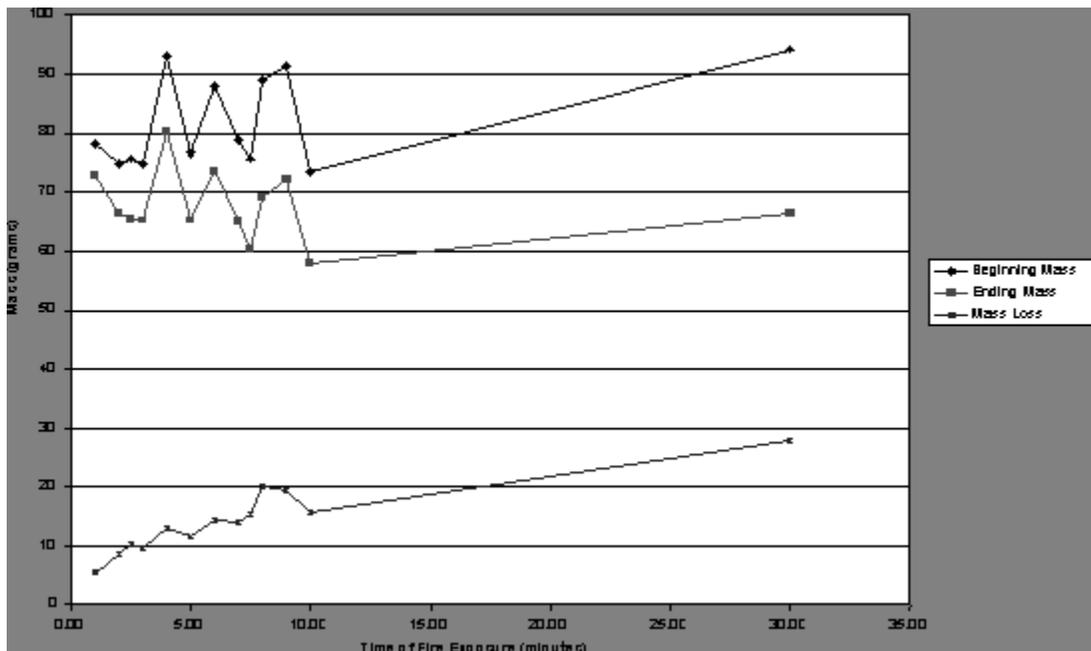
### 6. Mass Loss in Bench Tests

Significant mass loss and a corresponding decrease in density occur within the calcined portion of the GWB during the calcination process.<sup>6</sup> (This loss of mass and density was re-confirmed in the laboratory bench testing conducted in connection with this research project.)

Sample	Time in minutes	Initial Mass	Ending Mass	Probe Measurement	Visual Measurement	Mass Loss
E	1.00	78.1g	72.8g	0.13"	0.12"	5.3g
H	2.00	74.9g	66.3g	0.25"	0.15"	8.6g
C	2.50	75.6g	65.3g	0.23"	0.16"	10.3g
I	3.00	74.8g	65.2g	0.28"	0.18"	9.6g
G	4.00	93.1g	80.2g	0.33"	0.23"	12.9g
B	5.00	76.6g	65.2g	0.37"	0.24"	11.4g
F	6.00	87.8g	73.6g	0.42"	0.25"	14.2g
J	7.00	78.8g	64.9g	0.42"	0.31"	13.9g
D	7.50	75.6g	60.4g	0.32"	0.30"	15.2g
K	8.00	89.0g	69.1g	0.42"	0.24"	19.9g
L	9.00	91.4g	72.0g	0.44"	0.35"	19.4g
A	10.00	73.3g	57.8g	0.50"	0.27"	15.5g
M*	120.00	94.2g	66.4g	-	-	27.8g

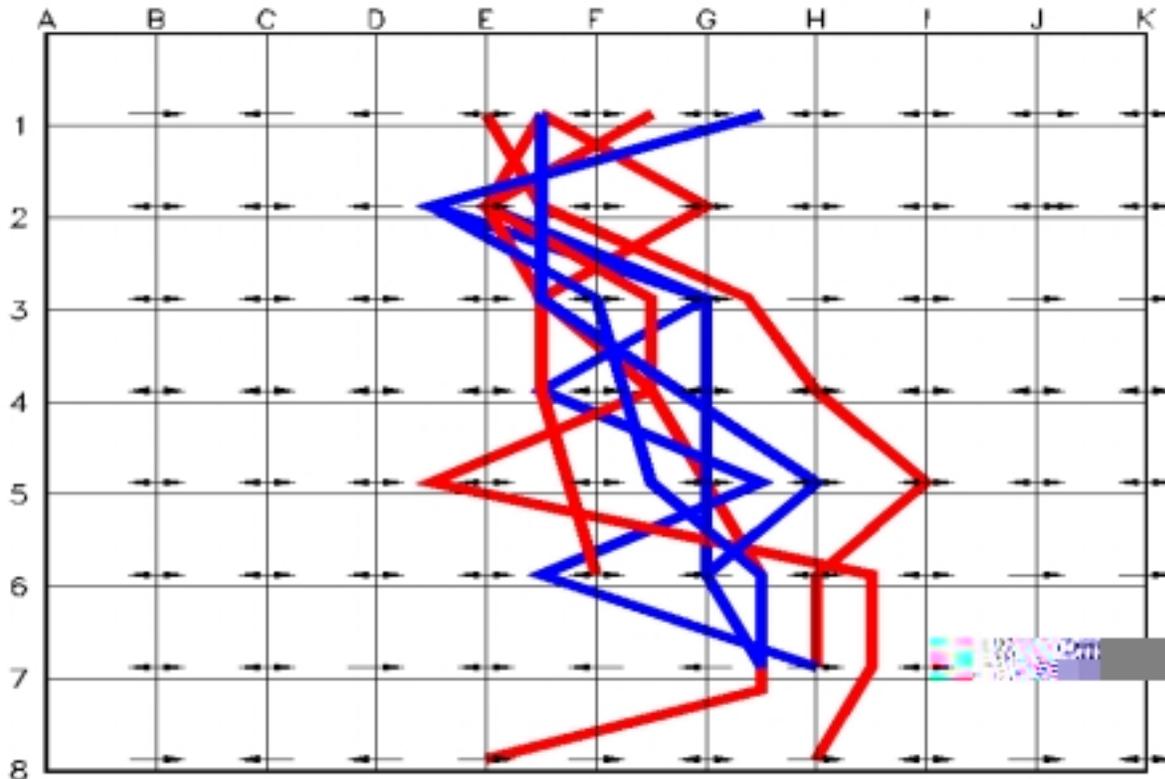
7. Mid-Point of Measurements of Bed Room with both Depth Gauge and Caliper

Though the individual depth of calcination measurements varied somewhat from individual to individual, the actual relative differences between adjoining measurements were largely similar.

The use of participants with widely varying skill and experience levels, two different types of measuring devices, and two different test rooms did not appear to have changed the overall tests results. Each of the participant’s individual results correctly identified the fire movement and spread laterally and vertically along the measured walls from the two separate points of origin. Collectively and on averaging the results, the grouped fire pattern analyses were also consistent with the known points of origin.
