# **FIRE PATTERN PERSISTENCE AND PREDICTABILITY ON INTERIOR FINISH AND CONSTRUCTION MATERIALS DURING PRE AND POST FLASHOVER COMPARTMENT FIRES**

Ronald L. Hopkins, MS, CFEL, CFPS  
Eastern Kentucky University, USA

Gregory Gorbett, BSc.(Hons.)CFEI, CFPS, MIFireE, IAAI-CFI  
John A. Kennedy & Associates, USA

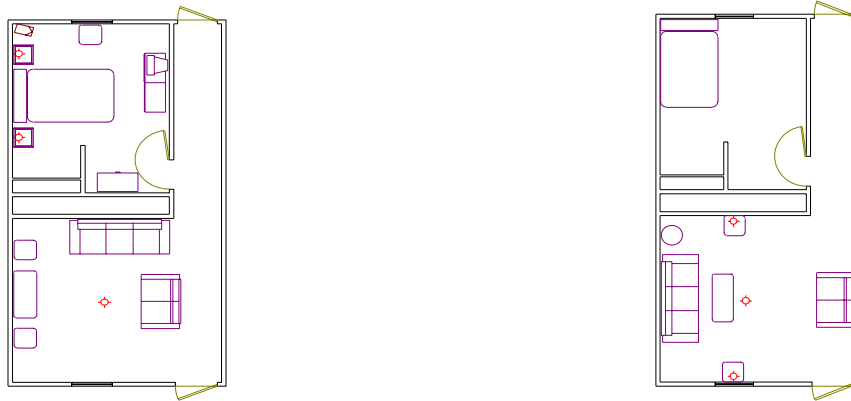
**Figure 3 Furniture Layout for Experiment Set A & C Figure 4 furniture layout for Experiment Set B & D**

*Experiment sets "A" and "C":* Experiment sets "A" and "C" (conducted in March 2005 and March 2006) were roughly identical in the layout and types of furniture (Figure 3). The rooms were furnished as typical residential bedrooms and living rooms. The contents of each bedroom included a bed, chest, two lamps, end tables, two nightstands, television (not included in experiment set #3), clothing and a dresser with an attached mirror. The bedrooms had wall-to-wall carpeting on the floor. The contents of each living room included a couch, loveseat, coffee table, two end tables, and television. The living room as well as the hallway had wall-to-wall carpeting on the floor.

*Experiment set "B" and "D":* Experiment set "B" and "D" (conducted in November 2005 and October 2006) was furnished as a residential living room. The living rooms consisted of a couch, loveseat, three

end tables, two lamps and a coffee table. The bedroom consisted of a single mattress with bedding material (Figure 4).

All experiment sets were ignited by the application of a propane torch to a small plastic bag containing a 4"x4" piece of cotton fabric rag doused with about 4 ml gasoline. Experiment sets "A" and "C" were ignited near the head of the bed on the polyurethane bedspread. Experiment set "B" and "D" were ignited near the center of the couch at the base of the vertical cushion.
