FIRE PATTERN PERSISTENCE AND PREDICTABILITY ON INTERIOR FINISH AND CONSTRUCTION MATERIALS DURING PRE AND POST FLASHOVER COMPARTMENT FIRES

Ronald L. Hopkins, MS, CFEL, CFPS
Eastern Kentucky University, USA

EXTENDED ABSTRACT

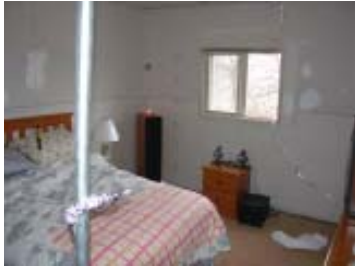
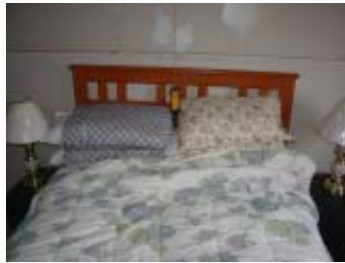
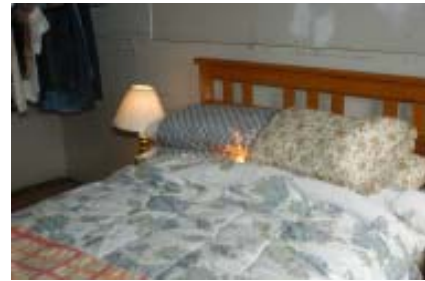
Experiment Set A: Experiment 1

The post-fire conditions of all room contents (i.e. bed, dresser, chest, etc.) for both experiments were similar. The dresser, chest and nightstands were all deeply charred, but remained primarily intact after the fire. The mattress and bedding were consumed during the fire, except for the metal frame and springs. The exemplar clothing originally hung in the closet was found in a pile at the bottom of the closet area and had been partially consumed during the fire. The plastic components of the television sets for experiment set “A” were consumed or melted away, but the metal components remained. The glass from the bedroom window was broken and no longer present.

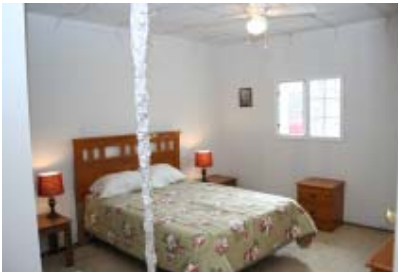
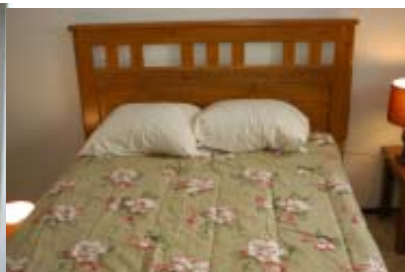
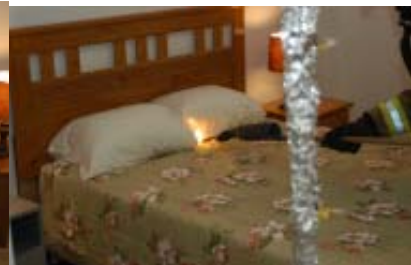
Experiment Set C: Experiment 5

Due to its unplanned shortened duration owing to the advent of extreme weather conditions, experiment #5 (experiment set “C”/cell #1) did not transition to full-room involvement before extinguishment. While this was not planned, it serendipitously provided substantial evidence of the early evolution of the patterns. This experiment compared to the other three experiments of similar ignition scenarios, prove that fire patterns existing pre-flashover conditions remain post-flashover. The patterns evolved from distinct lines of demarcation to more subtle lines of demarcation; however, it is evident that the patterns existed both pre- and post-flashover.

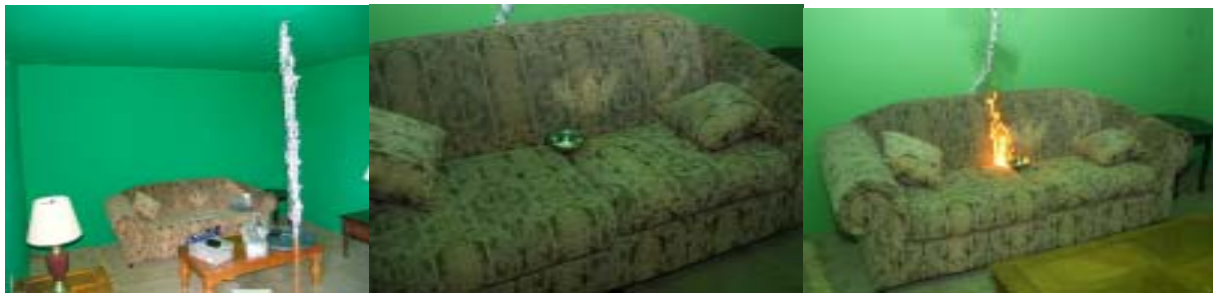
Experiment Set B: Experiment 3

Again, the post-fire conditions of all room contents for both experiments were similar. The loss of material patterns for the couch, loveseat, and end tables were very similar. Some of the differences between Sets “B” and “D” could be attributed to the duration of the burns. In all four test fires the ventilation patterns near the doorway were similar. The demarcation lines on the west wall corresponding to the airflow over the loveseat were nearly exact. Located on the east wall above the couch, a conical-shaped plume pattern existed in almost exact appearance between the two experiments. In fact, an almost perfect reproduction of the lines of demarcation remained on each wall behind the couch.
